Preventing accidents caused by unintended acceleration and subsequent continuous acceleration in automatic transmission vehicles

Abstract: The purpose of this study is to provide a fundamental solution from the viewpoint of Human Factors to the numerous accidents caused by unintended acceleration involving automatic transmission vehicles. Annually, an average of 6,900 accidents of this type have occurred in Japan in the last decade with a remarkably high fatality rate of approximately 3.44 %. This high fatality rate is caused by vehicles colliding with an obstacle at full throttle acceleration with an apparent loss of braking effectiveness. The main cause of this type of accident is believed to be human error since evidence of electro-mechanical defects is very rarely discovered in accident investigations. The likely contributing factor behind this type of accident is possibly the similarity of throttle and brake pedal placement and the identical method of operation. This pedal layout leads to pedal misapplication when intending to stop the vehicle. To prevent this type of accident, the authors removed the conventional throttle pedal from the driver's foot space and installed a pr

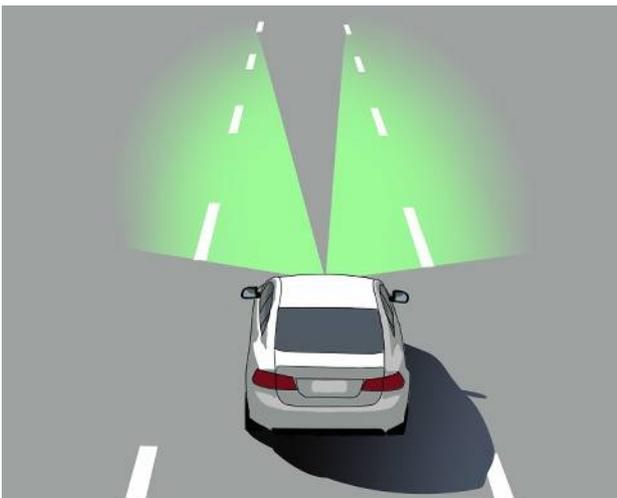
Fig.8 Lane departure alert (by cameras)

Automobile manufacturers developed devices using radar waves (See Fig.6), sonar waves, infrared-laser beams (See Fig. 7) or cameras (See Fig. 8) as sensors for obstacle detection, in coupling with automatic braking systems [10]. They put these on the market as CCUA prevention devices. These devices include the function of preventing UA while parked and starting the driving cycle. In addition, these obstacle-sensing devices include cameras capable of monitoring the periphery of the vehicle body and recognizing the white lines of a parking lot to prevent UA at start-up. Manufacturers have also provided emergency braking systems that can function at high-speeds (over 80 km/h) to minimize crash damages [10] whether or not the driver applies the brake. If the driver applies the brake, the automatic braking system will apply additional braking force and reduce collision damage. If the driver does not apply the brake, an automatic

emergency brake is activated. It is able to stop the vehicle as long as the relative speed difference between the two vehicles is less than approximately 30 km/h (See Fig. 6). These obstacle-sensing devices also include features such as an alert function for lane departure and a radar cruise control system coupled with moderate (non-emergency) automatic braking (See Fig.8).

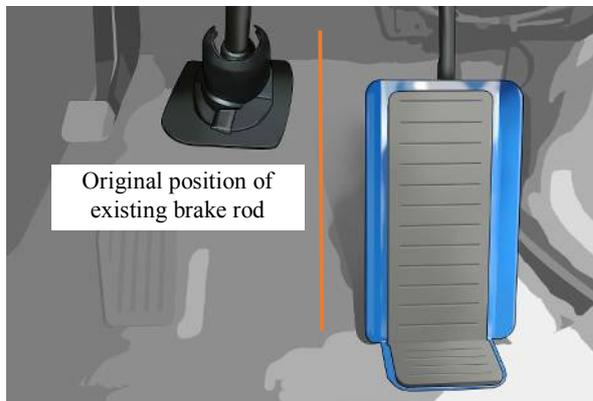
Fig. 19 Brake pedal (front-side view)

This system consists of (1) a hand-controlled throttle (See Fig.13, 14 & 15), (2) a right-leg-controlled brake (See Fig.13 & 19), (3) two steering wheel turning knobs (See Fig.13 & 18), (4) an extended turn signal lever (ETSL See Fig.18) / turn signal push button switch (TSPS left / right) (See fig.17) and (5) a mist wiper push button switch (MWPS See Fig.17). The hand controlled throttle body is a modified throttle position sensor, taken from the engine firewall and installed onto the center console (See Fig.13 & 14). To operate, the driver grasps the hand controlled throttle body with his or her palm and pushes the throttle lever forward with the ball of the thumb (See Fig.15). Double coil springs are installed inside the throttle lever, automatically returning the engine to the idling position when the lever is released. The traveling stroke of the lever is 2-5 mm in normal city driving including on the expressway (See Fig.15). The brake pedal is installed on the right hand side of the driving floor with three (3) stud bolts and is connected with a crank shaped rod to the root of the existing brake rod (See Fig.19) in the former position of the gas pedal (See Fig.19). When the driver senses a hazardous situation while driving, immediate braking application is permitted. The HAC-T brake system can be installed in any position of the driving floor so that it is feasible for left or right leg disabled people to use. Two single hand-operated turning knobs enable single hand operation of the steering wheel, such as on an upslope corner. These are installed at the 2- and 4 o'clock position on the steering wheel (See Fig.13 & 18). Furthermore, a speed sensitive type of power steering system for drivers with weak gripping strength, such as the elderly and female is also installed. Additionally, a two-way turn signal system is also installed. An extended turn signal lever is installed on the existing turn signal lever to enable activation by grasping the turning knob (See Fig.13 & 18). Finger operated turn signal buttons are also installed on the hand controlled throttle body (See Fig.17). The right turn signal switch is operated with the forefinger and the left turn signal switch is operated with the fourth finger or the middle finger (See Fig.17). Both push button switches are push-ON and push-OFF. The mist wiper function push button switch (to wipe the windshield for one cycle) is also available for the little finger or the fourth finger operation on the hand controlled throttle body along with one time water spray function (See Fig.17).

delicate than leg application. It is possible to control the engine revolution in as small as 100 RPM increments. The right foot placement of the HAC-T brake pedal (See Fig.19) fulfills the natural driving position for the driver because the HAC-T brake pedal is installed in the position of the removed gas pedal and immediate application is feasible without changing leg position. According to a judicial precedent of the Supreme Court in Japan, changing the leg position from the gas pedal to the brake pedal takes an average of 0.8 seconds plus alpha.
